Have a blockage in your KTW Mist Ring?

What is happening?

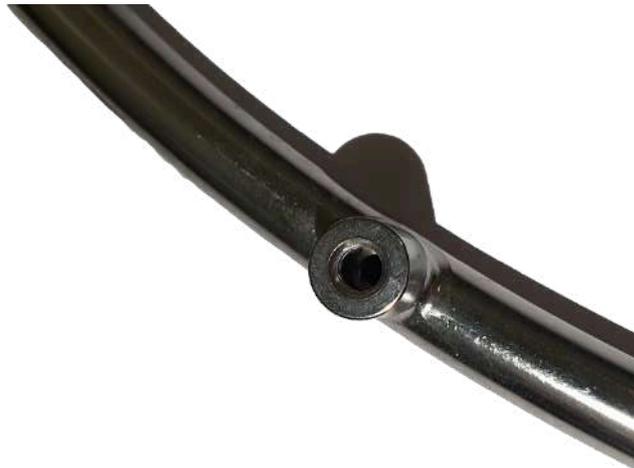
Some mist rings have been supplied without the nozzle holes pre-drilled. This issue likely occurred due to a manufacturing oversight, where the drilling step was missed during production.

Rather than returning the mist ring to OZmist, this guide will walk you through a simple process to correctly drill the holes and install the nozzles, ensuring your system operates as intended.
