## Vibrating Fans? Here's the quick fix.

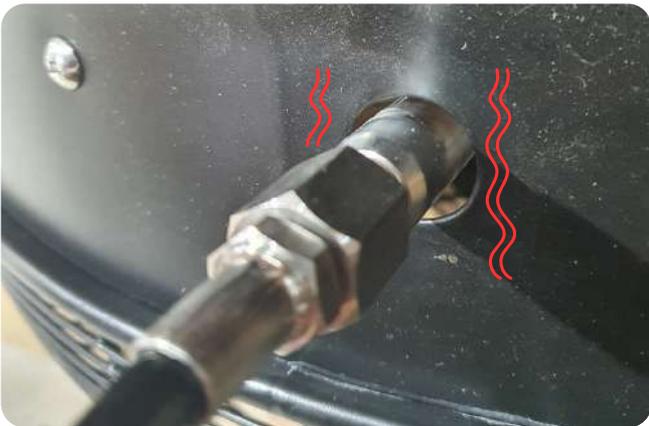
Sometimes from assembly the Misting Rings can be installed slightly off centre, this will cause the Ring to make contact with the outside casing of the Fan.

This will generally cause no issue when the Fan is operating alone, but when Mist is introduced from one of our High-Pressure Pumps, the action of the Pump forcing water through the lines will cause vibration. And you guessed it, the Mist Ring will vibrate and cause an irritating noise as it rubs the Fan casing.

If the Mist Ring can not be manually adjusted so that it clears the through hole and makes no contact.

Contact OZmist and we will send out Rubber packing that can be used to dampen any vibration. This can be seen in the image below.
